# Lightning protection of a cable-stayed bridge

A. Rousseau, SEFTIM<sup>1</sup>, L. Boutillon, VINCI Grands Projets<sup>2</sup>, A. Huynh, FREYSSINET<sup>3</sup>

**Abstract--** On the 27<sup>th</sup> of January 2005 one of the longest stay cable bridges in the world has been struck by lightning leading to the failure of one stay cable. This event has been thoroughly studied in order first to explain the failure mechanism and then to find appropriate protection solutions. Many tests have been performed either on components or on the whole stay cable including metallurgical inspections, mechanical, high voltage and surge current tests. At the end of the investigation period the scenario of the failure has been established and enhancement of the existing lightning protection system has been defined and implemented..

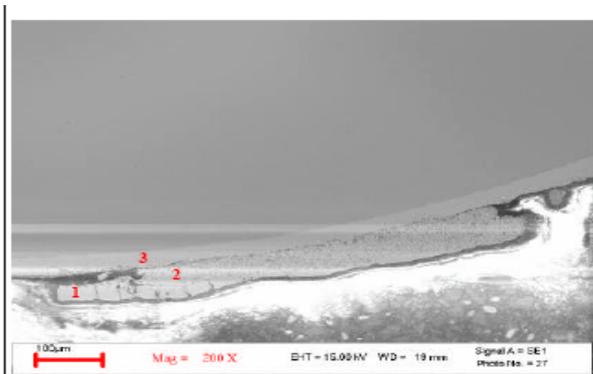
Fig. 1. Detail of the porous area made of zinc located at the observed marks. Grey zone at the top is made of steel (no alteration).

Inspections and tests enabled to conclude that the direct damages induced by the lightning strike were limited to the zinc layer (melting) without affecting the steel of the wires.

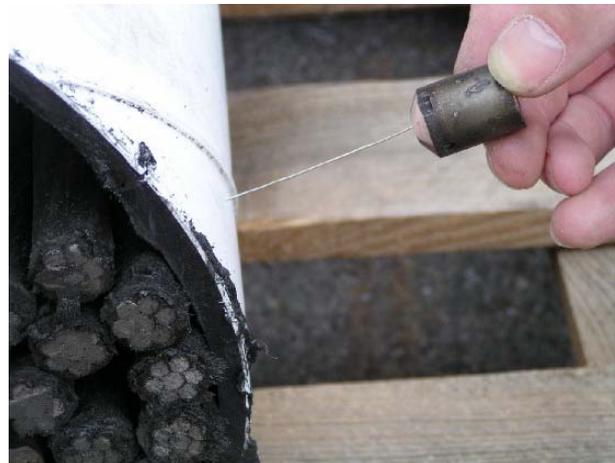
Fig. 2. Fuse wire connected to one of the strand inside the duct

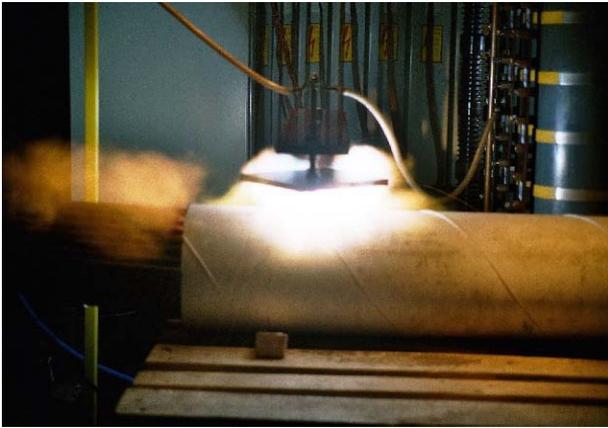
Fig. 3. Tests performed on the free length.

Then we performed tests on a complete assembly reproducing the top stay cable. Tests performed over the free length confirmed the expected high fire resistance. Even tests made of combination between high impulse current (up to 50 kA) as per IEC 62305-11 and long duration (up to 680 C) lead to stop of fire after 5 s. Tests in vicinity of the collar led to results similar to those obtained during the flame tests. It was needed to have both a 500 C current and a 10 mm diameter hole to generate a small fire which did not self-extinguish and that we had to stop manually.

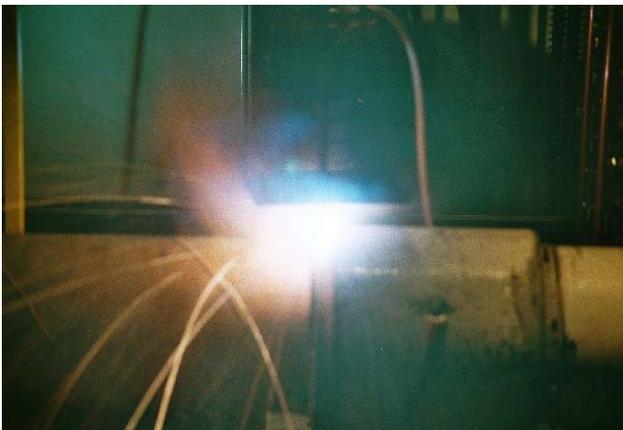
Fig. 4. Tests performed near the collar.

The upper stay cable has been struck very likely by a lightning flash nearby its upper collar, on the upper side, which was an attracting point.

The flash was powerful enough to punch the HDPE outer duct of the stay cable creating a hole larger than 10 mm in diameter. It has then impacted the strands in at least eleven locations, generating a superficial melting of the wires zinc layers. The conditions near the collar and the

electrical charge transferred were such that a small fire was ignited at the edge of the hole in the HDPE duct. Despite the wind and the probable rain, the combustion did not stop. Once the fire of the duct was strong enough to burn by itself, the heat was transmitted to the steel strands.

- Use fire retardant material in the vicinity of the collar to modify the local conditions and to prevent the fire from starting
- Reduce the number of potential flashes to the top stay cables by installing stretch wires above them.
- Try avoiding collars to be preferential impact points

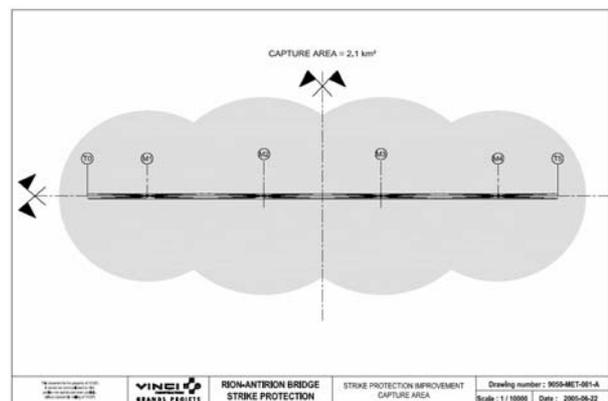
The lightning capture area for the whole bridge has been determined in accordance with IEC 62305-2 and is equal to 2.1 km<sup>2</sup>, see Figure 5. As this part of Greece as a keraunic level around 30, the expected number of lightning flashes is around 6,3 per year. The expected number of flashes to the stay cables has been estimated in the same way to be 4 per year. Surges counters installed on the down-conductor suggest that at least 21 lightning strikes hit the pylons from August 2004 to June 2005.

Fig. 5. Calculated capture area.

This is 3 times bigger than what we could be expected from the keraunic data. New surge counters measuring current, charge and having time stamp will be fitted to better determine in future what is the exact number of lightning flashes to the pylons.

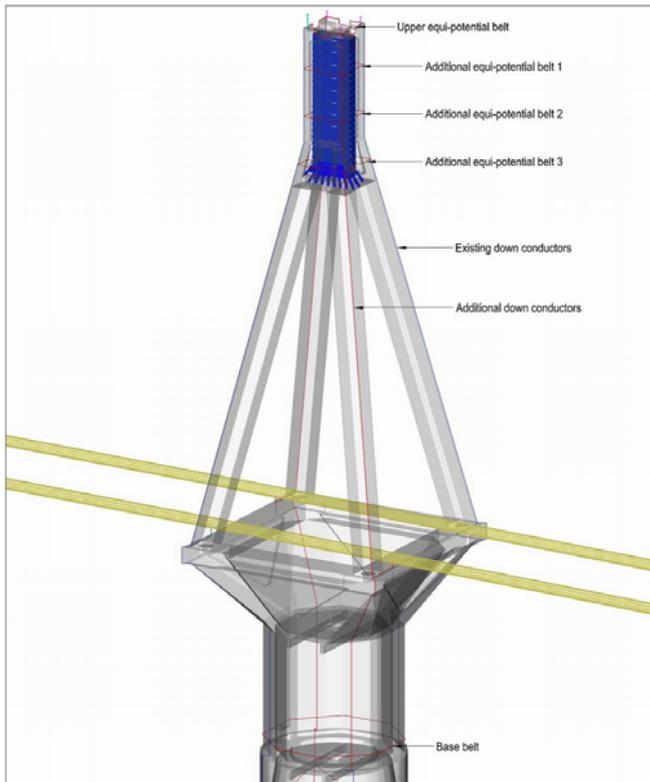
Fig. 6. Enhance pylon protection

As it was likely that corner and edge of the top part of the pylon be the preferential attachment point, a ring conductor with 4 rods at each corner have been installed. Two additional down-conductors have been also implemented to make a mesh as well as 3 more ring electrodes evenly spaced from top of the pylon to the bottom of the metallic stay cable anchorage box. Another ring conductor has been installed at sea level to share the current between 4 earthing systems. Equipotential bonding of pylon metallic part has also been provided (see Fig. 6).

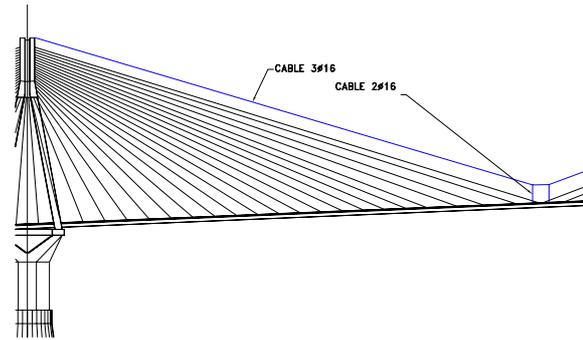
Fig. 7. Stretch wire and stay cables

Stainless steel high strength strands have been used to build a stretch wire above the top stay cables, connected to the pylon mast upper ring conductors. The stretch wire is running parallel to the upper stay cable and is connected at mid-span to a central piece which is attached by hangers to the deck. The tension in the stretch wire is close to the tension in the stay cable strand so as to have similar deflections in order to ensure a minimum distance between stretch wires and stay cables. Safety distance has been calculated so that even in case of strong wind and lightning occurring at the same time the distance between the stretch wire and the upper stay cable always remain above the spark over voltage. At last redundancy ensures that no stretch wires can fall on the deck even in case of exceptional strike.
