Direct Lightning Withstand of Corrugated Stainless Steel Tubing for Gas

Alain Rousseau
SEFTIM

Mitchell Guthrie
Engineering Consultant

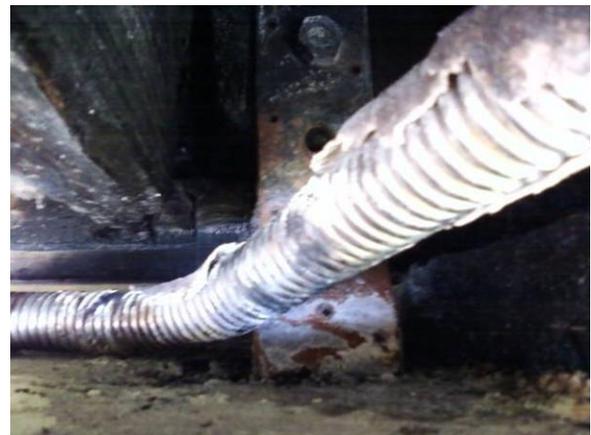
Figure 1. Location of CSST Damage Near a Strap Connected through a Concrete Footing

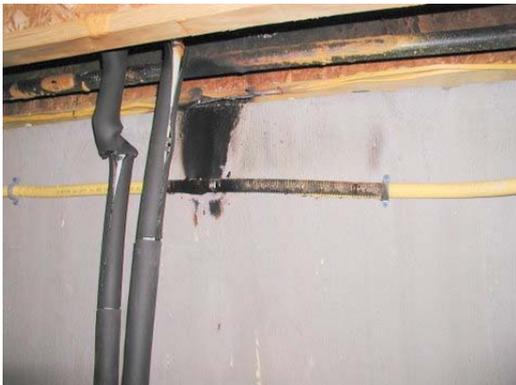
Figure 2. View of damaged CSST near two insulated vertical pipes below horizontal electrical cables and metallic water pipe

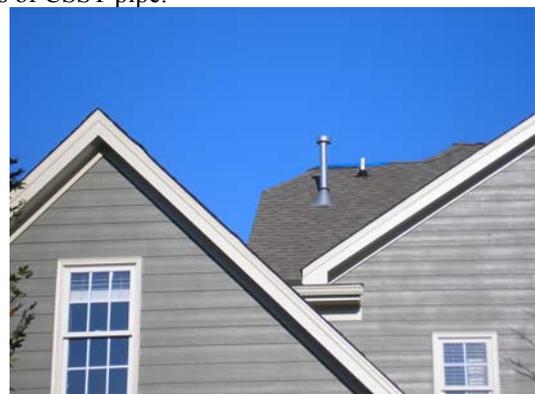
A review of the evidence indicated there were numerous holes in each of two CSST pipes in the proximity of the origin of the fire. Evidence supported by data from the National Lightning Detection Network (NLDN) suggests that there was a -12.3 kA lightning strike to the vent pipe shown in Figure 3 which was attached to the water heater. The water heater had no electrical service but was provided with copper water lines. There was evidence of arcing at the screws attaching the vent pipe to the water heater and from the feet of the water heater to the metal catch pan on which it was installed.

The gas supply to the water heater was provided by a T-connection with one side coming from the utility room and the other continuing into the laundry room. It is surmised that the CSST piping on both sides of the water heater experienced a significant portion of the lightning current through the piping and finding the path to ground through the electrical service provided to the clothes dryer and the furnace and it is this partial strike current that that caused numerous holes in both sections of CSST pipe.

Figure 3. View of vent pipe on roof which served as the strike attachment point

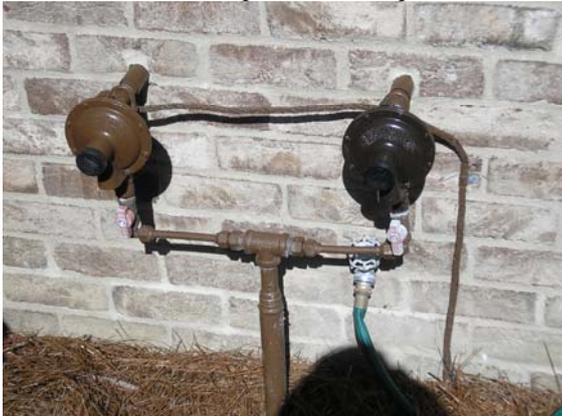
Figure 4. Bonding of incoming gas piping to LPS using main-sized conductor

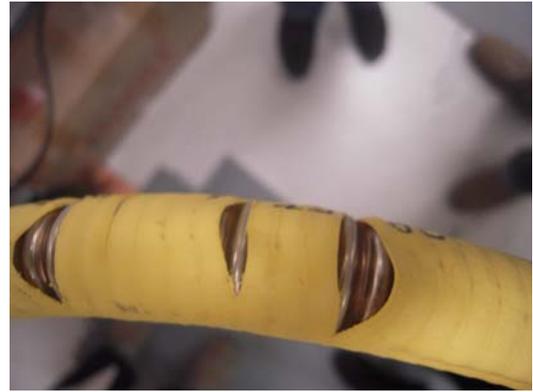
As can be seen from this table, it was not possible to damage the steel part of the CSST sample, even with a 50 kA current. At 10 kA no visible evidence of damage could be noted. The samples were filled with pressured air and no holes were found in these samples. At 50 kA only the jacket was damaged. Once again, there was no puncture of the steel tubing but the jacket was partially destroyed. Surprisingly, the product with a jacket designed to better withstand the lightning stress had more jacket damage than the standard version.

This can probably be explained by the fact that this jacket is not developed to withstand such high currents and the lower longitudinal resistance will result in greater current flow through it, leading to thermal and mechanical effects on the jacket.

Figure 6. Example of test results - test 10

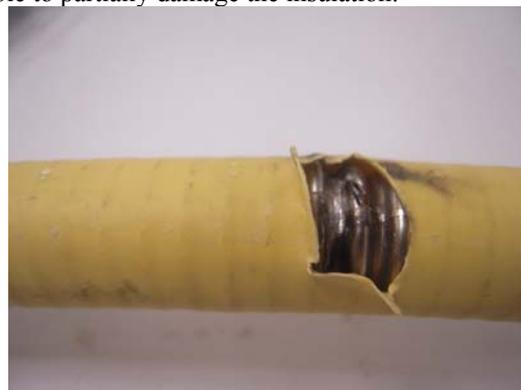
Figure 7. Example of test results - test 6

Once again, we obtained no damage (test 11) when the CSST was tested alone but when in contact with a metal plate near the location where the jacket was pre-failed, we obtained 2 marks at 10 kA (test 6) and 3 holes at 50 kA (test 12).

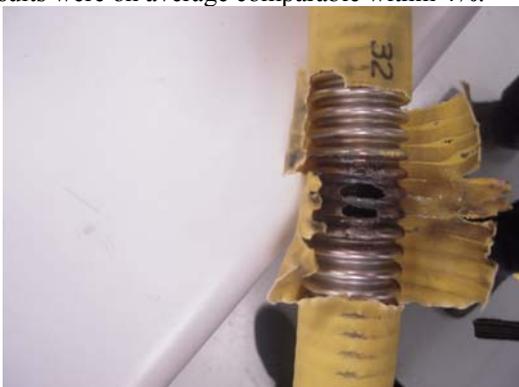
In these two cases, it was demonstrated by air pressure testing that the sample was leaking. In addition, when the measured voltage obtained during tests is compared with a simulated value taking in consideration the magnitude of current, waveshape, and impedance (both resistance and inductance) measured by an impedance meter, we found that results were on average comparable within 4%.

Figure 8. Example of test results - test 12
