Application of aircraft lightning protection to radar stations

C. Bruel, D. Barilleau, A. Rousseau

SEFTIM, 49 Rue de la Bienfaisance, 94300 Vincennes, France – info@seftim.fr

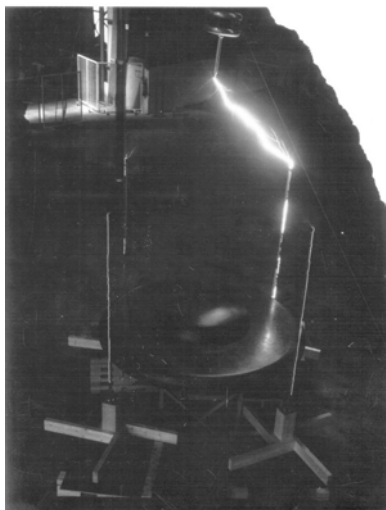
The 5 MV generator was one more time use for these tests and the current injected in one of the rods was around 5 kA. Values of voltage as high as 840 volts were found on a 10 k Ω resistance. It was then decided to study a protection scheme based on all the measurements made.

Figure 3 : LEMP tests. We can observe the sparkover along the lightning diverter strips

This protection scheme included :

- A better shielding of some cables
- A better shielding of some sub-systems
- A better equipotentiality between elements
- A common 0 V reference
- Some SPDs located on cables connected to the ground.

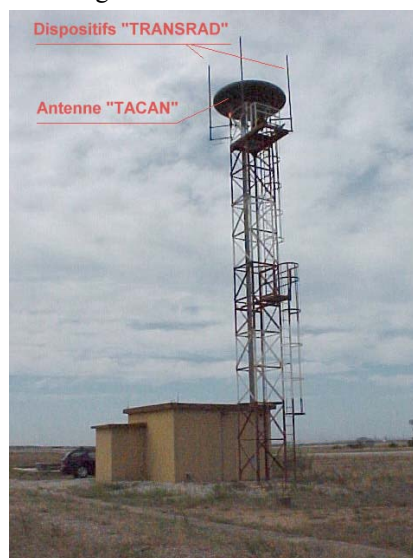
Figure 3 : Testing in field

Finally other tests have been performed to demonstrate that the protection scheme was not modifying the antenna characteristics. These final tests were made in field on a true antenna.
