Direct Lightning Withstand of Corrugated Stainless Steel Tubing for Gas

Alain Rousseau
SEFTIM

Mitchell Guthrie
Engineering Consultant

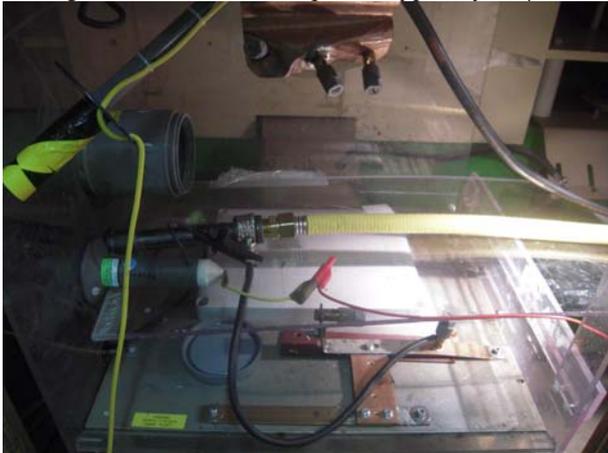
The CSST sample was terminated on both ends by a threaded steel tube that adjusts to the CSST fittings as it would in a normal installation. The steel tube and CSST fitting is shown in Figure 5.

Figure 5. The 10/350 direct lightning experiment
